Hartford Steam Boiler

## Learn From Loss College Student Housing Fire

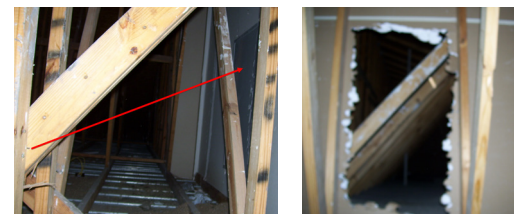
Allowed self-closing door with automatic latch in the draftstop wall of an attic.

"Unapproved" opening in a draftstop wall.

membrane, usually fire rated sheetrock, used to subdivide an attic space to resist the passage of smoke and heat. The codes require that after installation, the draftstop(s) must be properly maintained. A draftstop was not addressed in the SFMO report, however smoke issuing from the attic at both ends of the building early in the fire raises the question as to the installation and/or the maintenance of a draftstop. For those who inspect buildings, one should verify that a draftstop is properly installed and that it is sufficiently maintained.
