Thermography Services

HSB Thermography overview

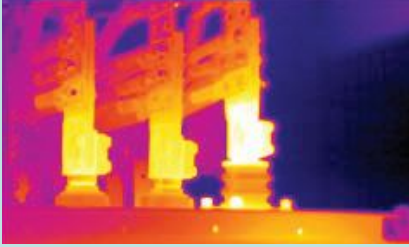
Overheated transformer bushing
A transformer experienced an internal problem that a thermography survey revealed as an overheated bushing. Within 24 hours, the transformer was shutdown, and a back-up unit was installed. This averted potential spoilage of millions of dollars in agricultural products.

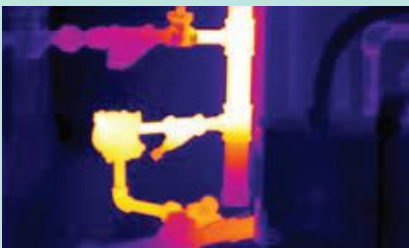
A properly operating steam trap
Not all hot spots indicate a problem. This image shows a steam trap that is operating properly. Faulty steam traps waste energy; infrared thermography is an invaluable tool for readily detecting them so they can be repaired.
